Home HUBER Report Pulborough STW Inlet Screen Upgrade - A Wastewater Case Study Pulborough STW Inlet Screen Upgrade - A Wastewater Case Study

Huber Technology completed the inlet screen upgrade at Pulborough STW, installing two HUBER Micro Strainer ROTAMAT® Ro9 / 700's on an elevated inlet works.

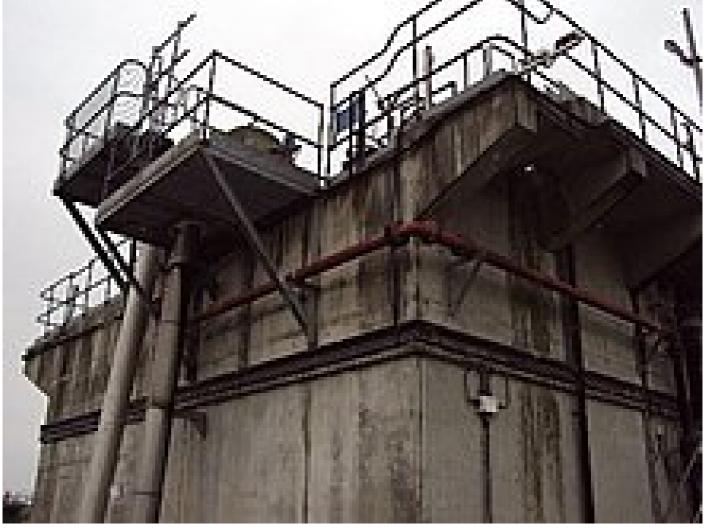
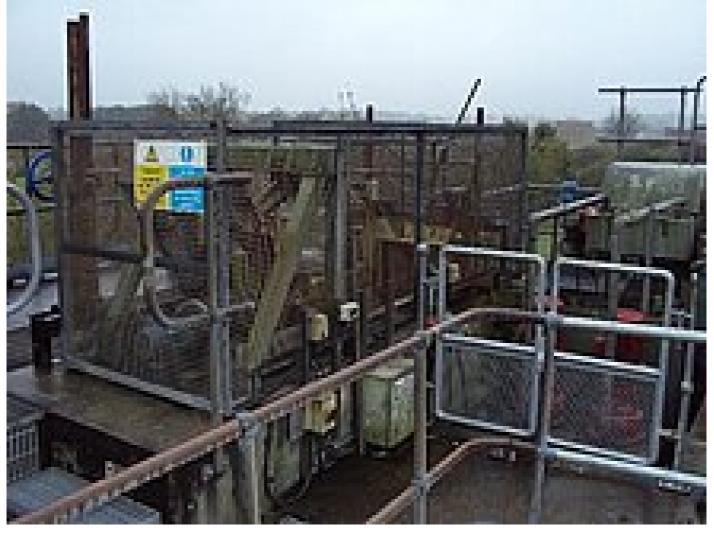
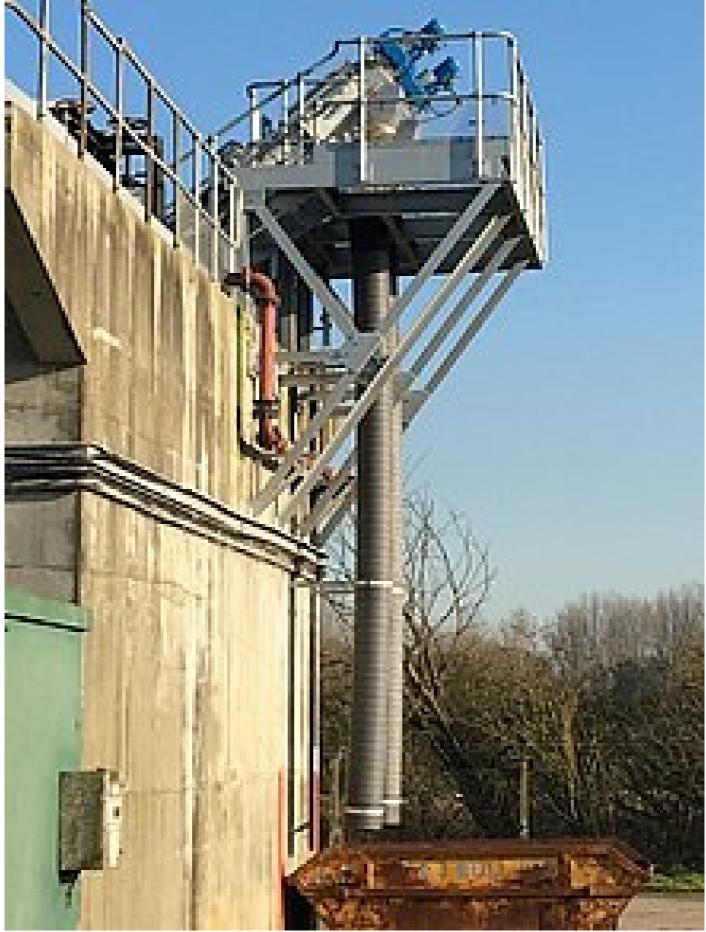
The maximum size Ro9 / 700 was agreed and fitted to meet the maximum inflow of 160 l/s. It was also decided to fit two screens and remove the existing bypass bar screen.
