## Solution for Plugging Problems in Wisconsin, USA

The Village of Oostburg, WI was experiencing clogging problems throughout their wastewater treatment plant. The clogging was due to a malfunctioning comminutor of their influent pump station in their headworks structure. The existing grinder was often out of service and repairs were very costly. It was the desire of the City to upgrade the plant by installation of a fine screen.

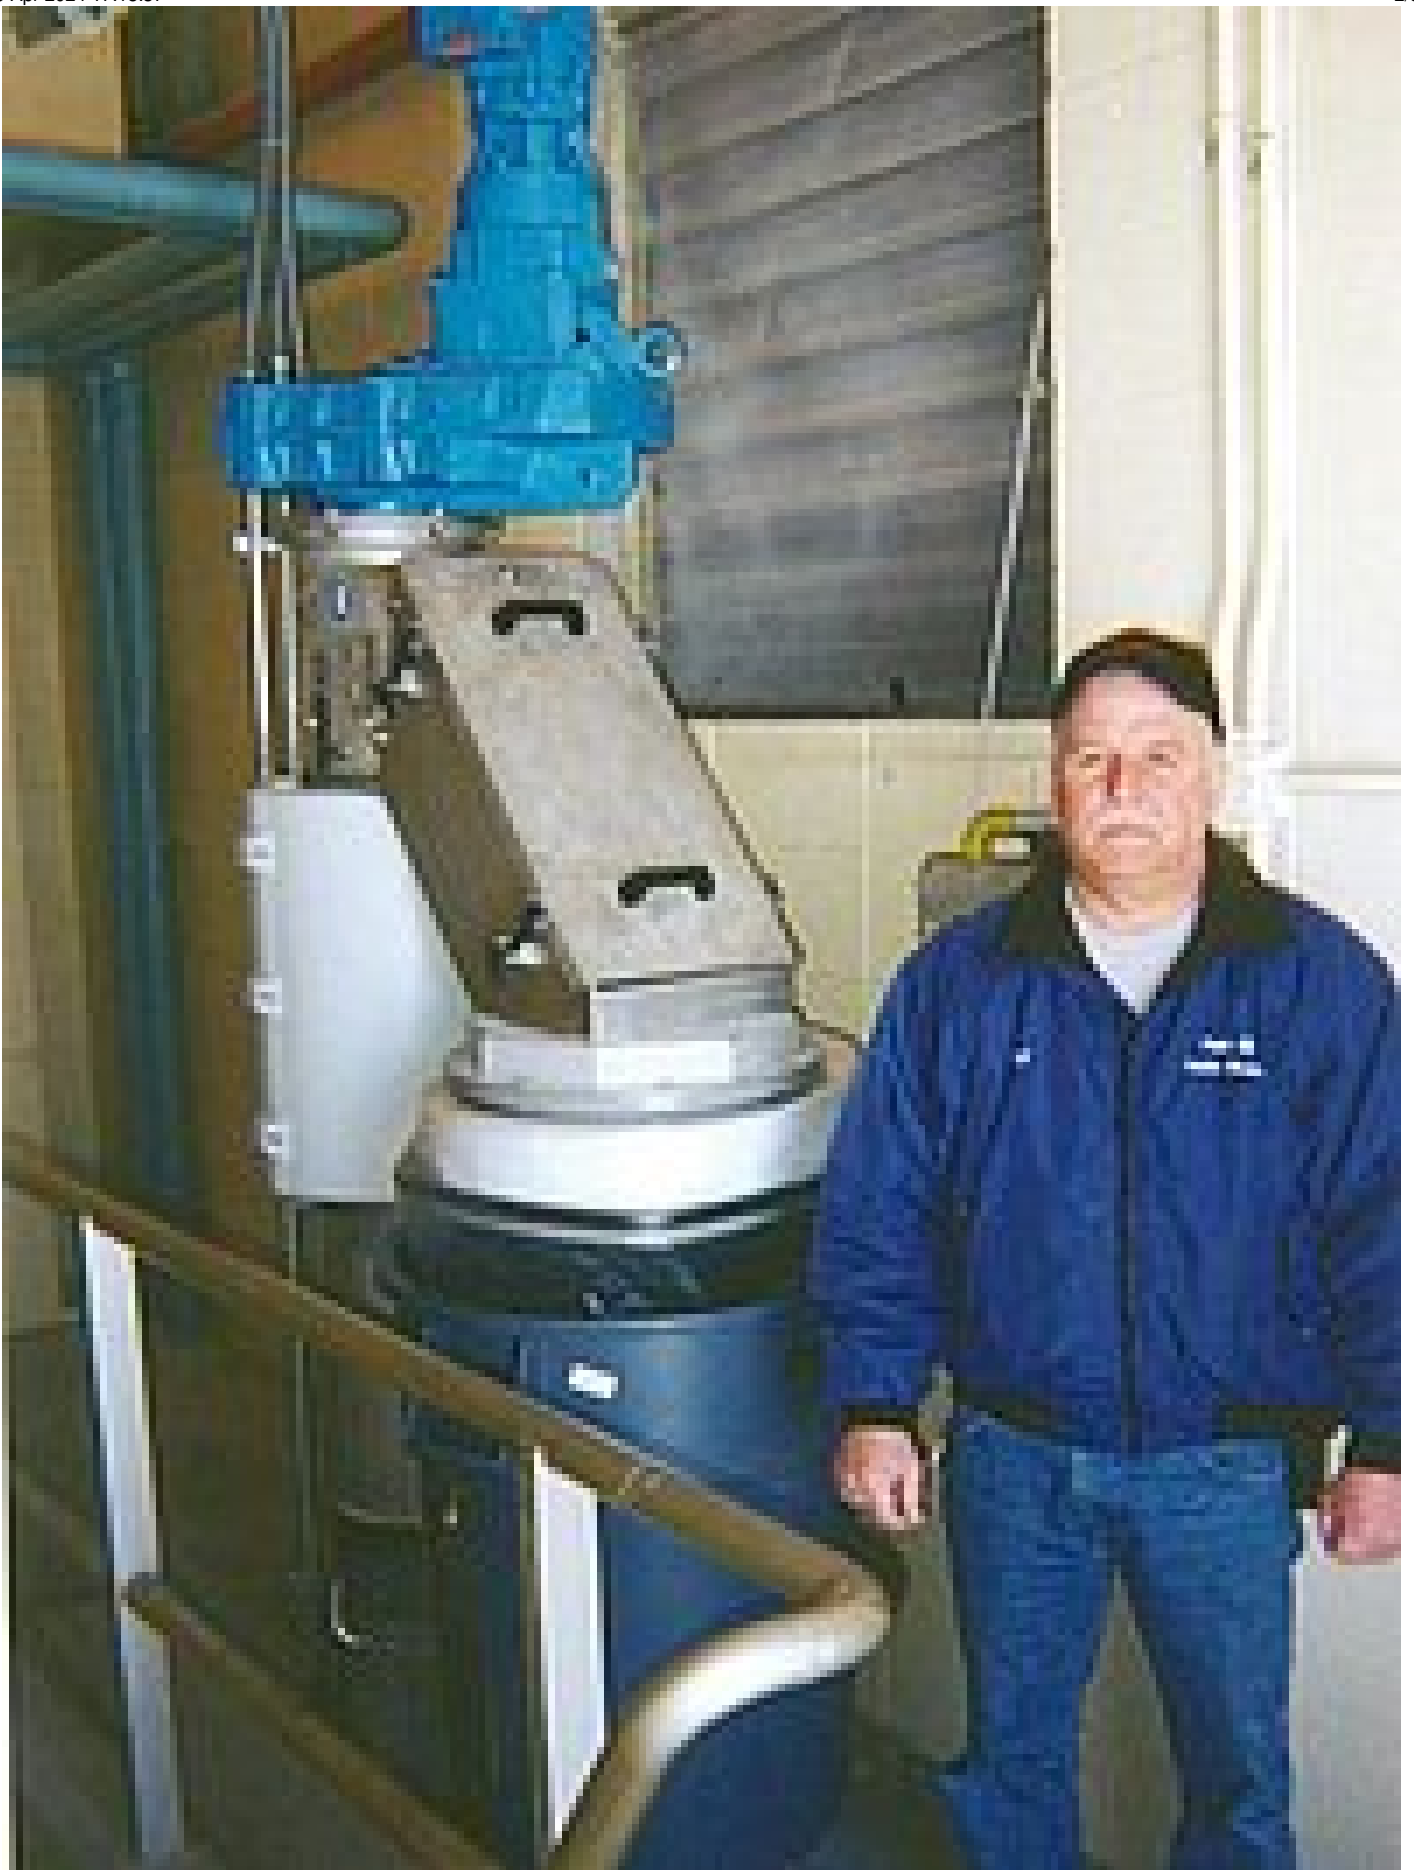
Chief Operator Phil Dulmes: „This is the best thing we ever did. We no longer have to manually clean out rags and other debris“

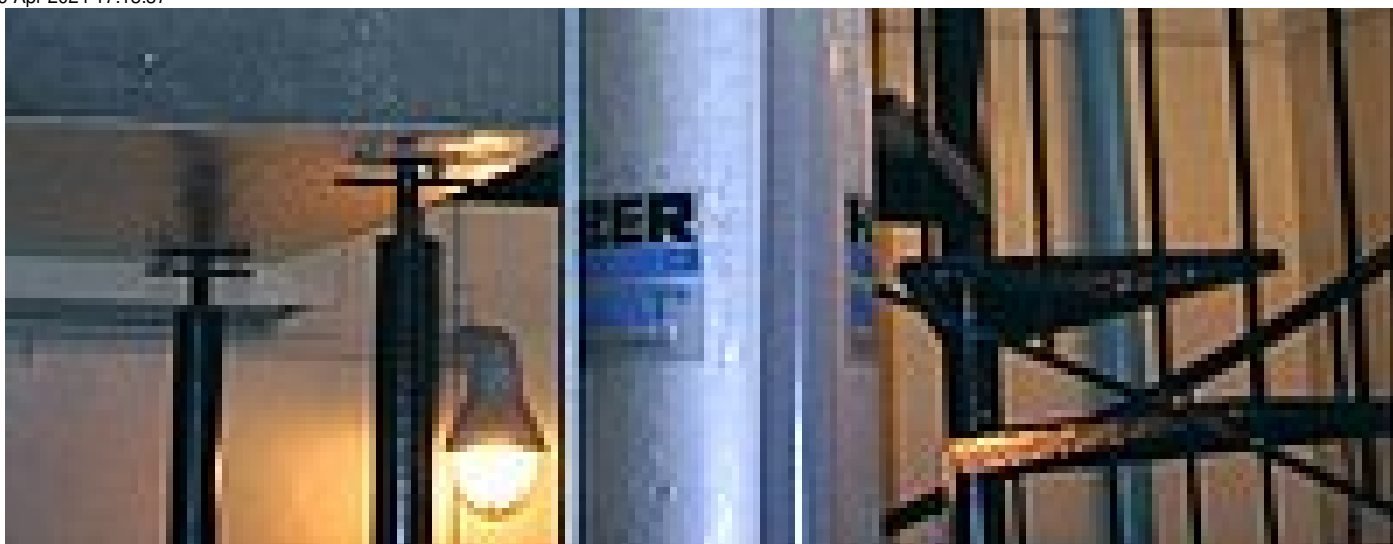
Vertical screenings transport tube of the RoK 4

HUBER TECHNOLOGY, offering the widest range of screening technologies worldwide, had the solution to solve this problem. The RoK 4 vertical drum screen could be installed in the very short channel and could lift the screenings to the desired height without any need to modify the building. It was the consultant's idea to place the screen basket in the same location as the grinder and lift the screenings vertically to the upper floor for disposal. The RoK 4 does not only screen the wastewater but also washes, transports, dewater, compacts and deposits the screenings into an endless plastic bag. All this is accomplished on one square meter of floor space.

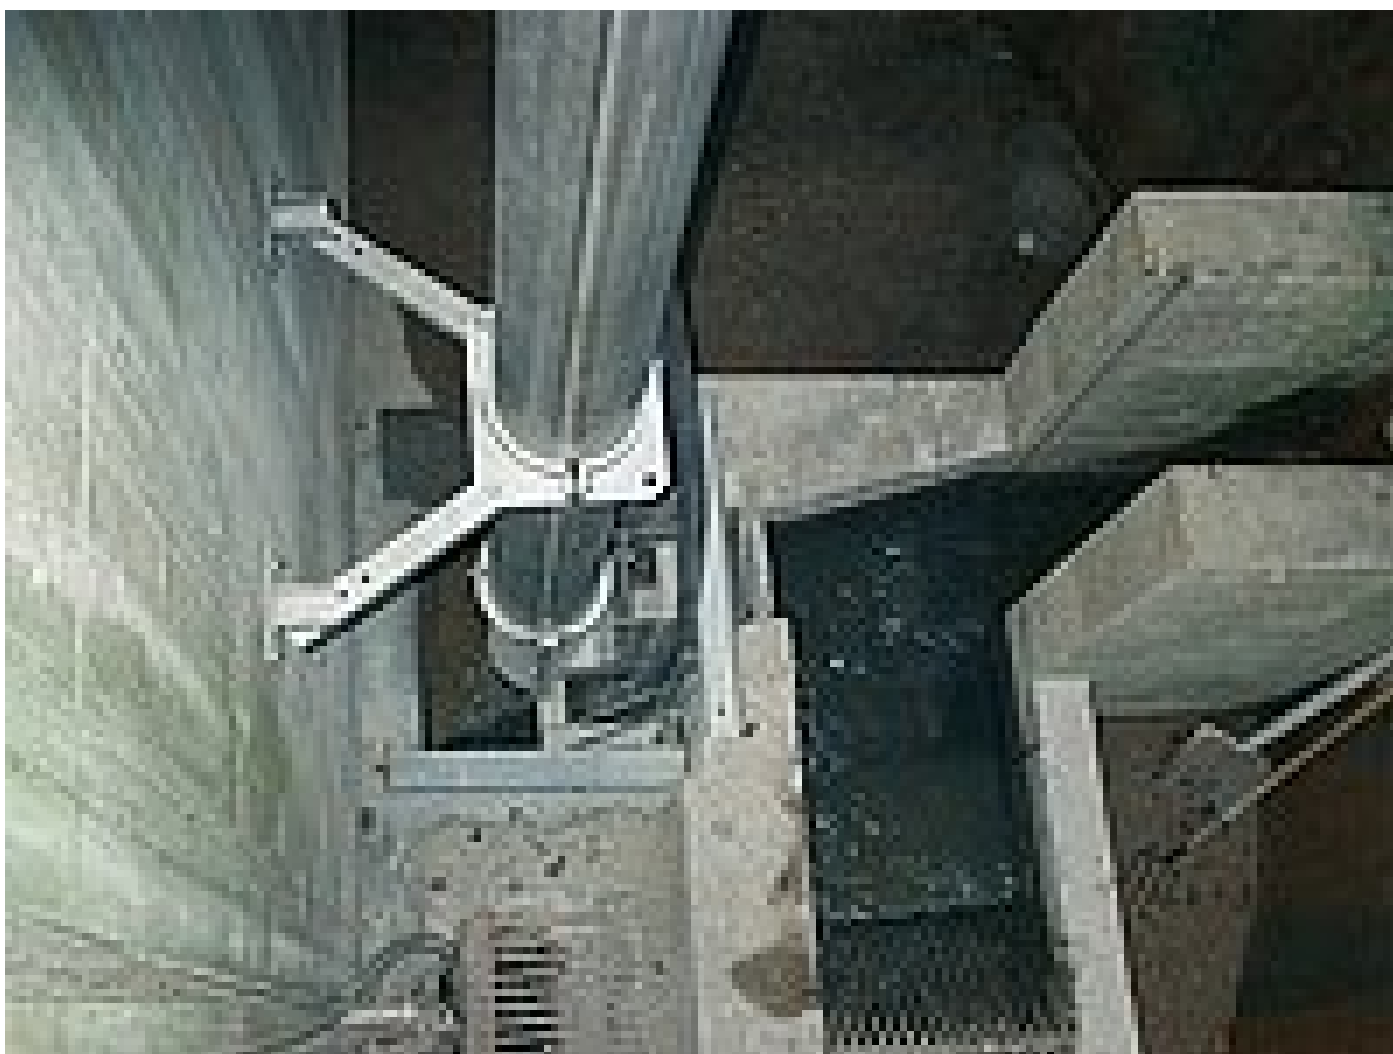
Lower section of the RoK 4 with screen basket and IRGA for screenings washing

We modified the standard machine's piped inlet to match the inlet-channel's rectangular cross section. We accomplished this by removing the pipe inlet and modifying the inlet box with angles that could be attached to the channel. The design team working with HUBER engineers came up with a clean, safe and cost effective solution. The plant has not experienced any clogging problems since the screen was brought online. The Village of Oostburg is very satisfied with the performance of the new screen.
